# 2nd Greek – Romanian Seminar

*Lessons learned from  
Earthquakes and Geotechnical Failures*

This is the compiled pdf version of the presentations by speakers who presented at the 2<sup>nd</sup> Greek-Romanian Seminar on Earthquake and Geotechnical Engineering “Lessons learned from Earthquake and Geotechnical Failures”, organized by the Hellenic Society for Soil Mechanics and Geotechnical Engineering (HSSMGE) and the Romanian Society for Soil Mechanics and Geotechnical Engineering (SRGF) in Thessaloniki, Greece, on the 9<sup>th</sup> of October 2025.

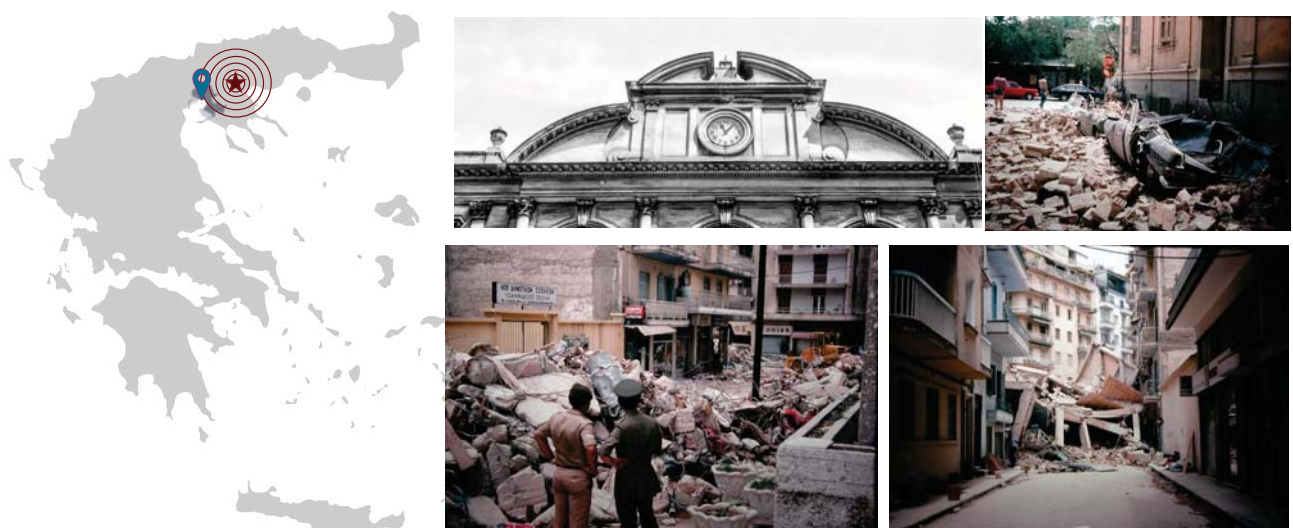
## Case study: Mw6.5, Thessaloniki 1978 event

- Distribution of damages inferred by the Thessaloniki building stock for the Mw 6.5 1978 Thessaloniki Earthquake
- Considering:
  1. **Fixed-base-on-rock (FB)**: Fixed-base fragility functions and no SAmP
  2. **Fixed-base-on-soil (FB+Samp)**: Fixed-base fragility functions and SAmP using amplification factors in GMPEs
  3. **Flexible-base-on-soil (SAmP+SSI)**: Fragility functions accounting for SSI and SAmP

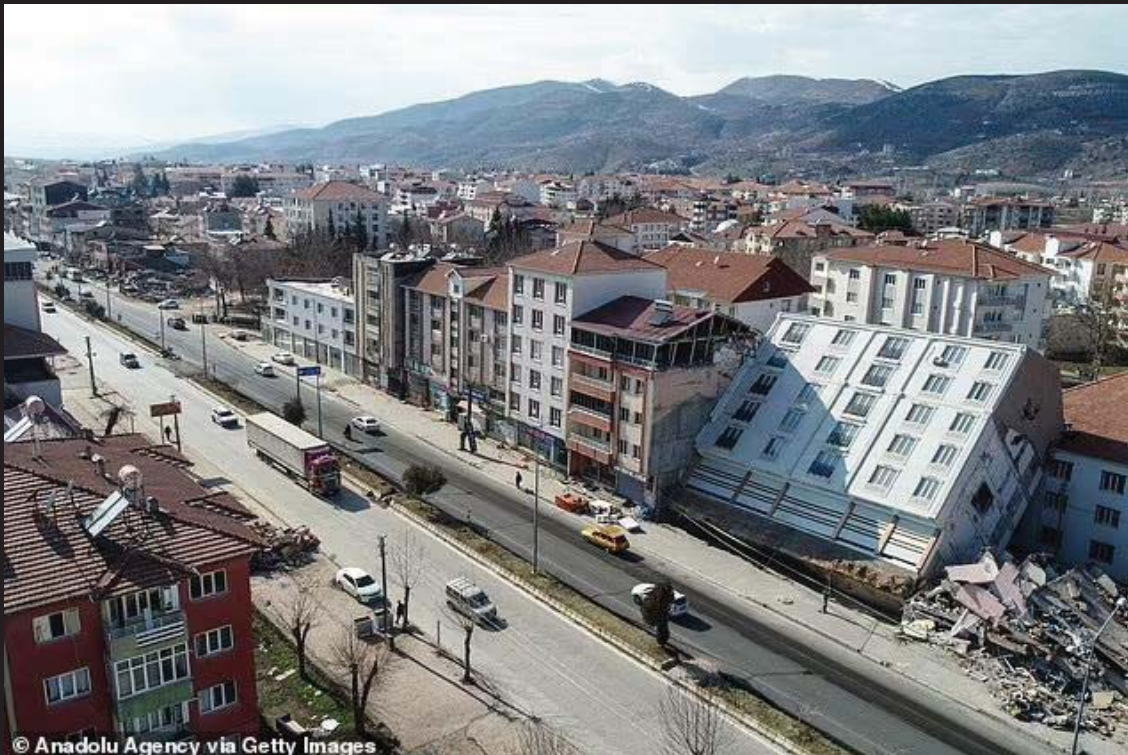
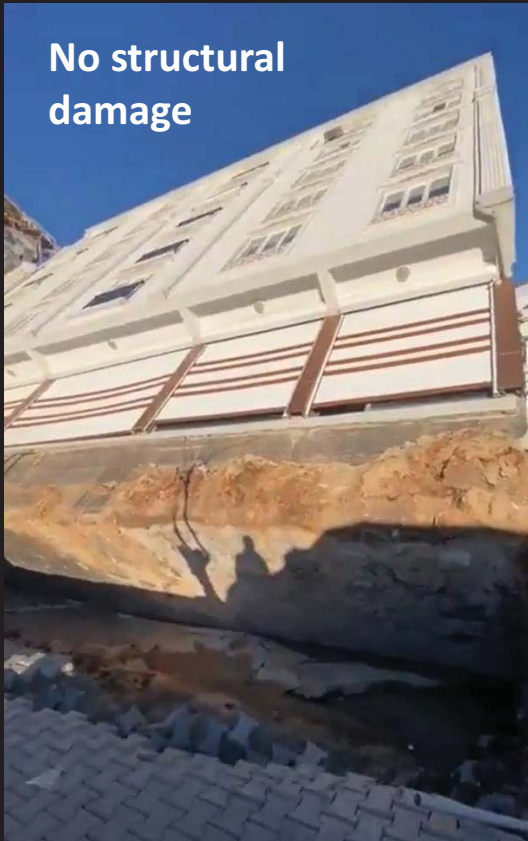
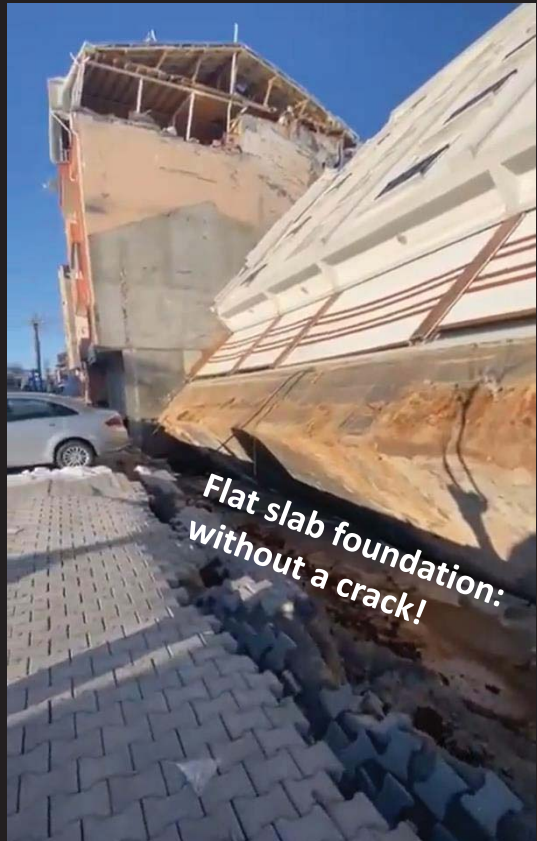
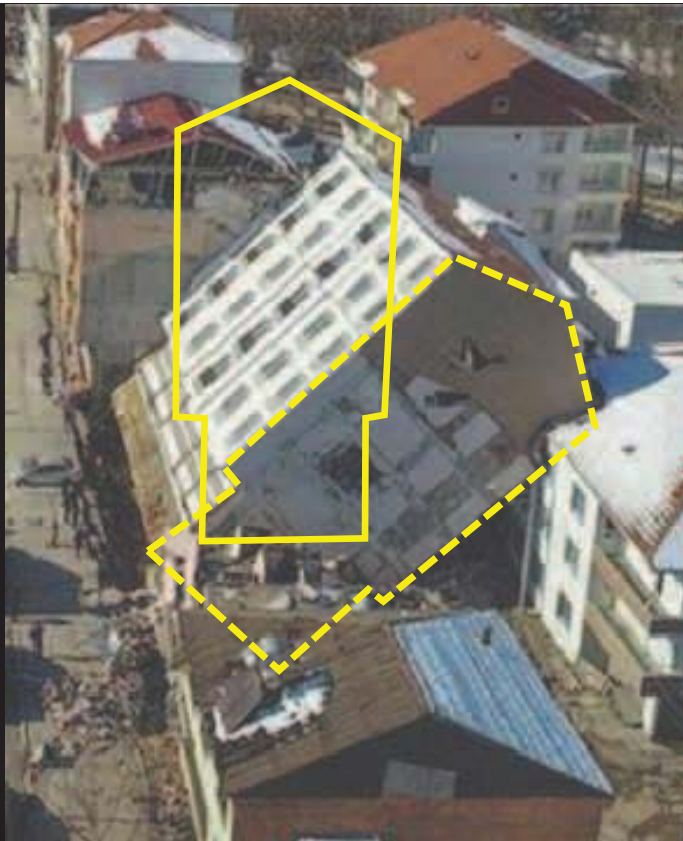
## A toppled building in Gölbaşı

No structural  
damage

Flat slab foundation:  
without a crack!

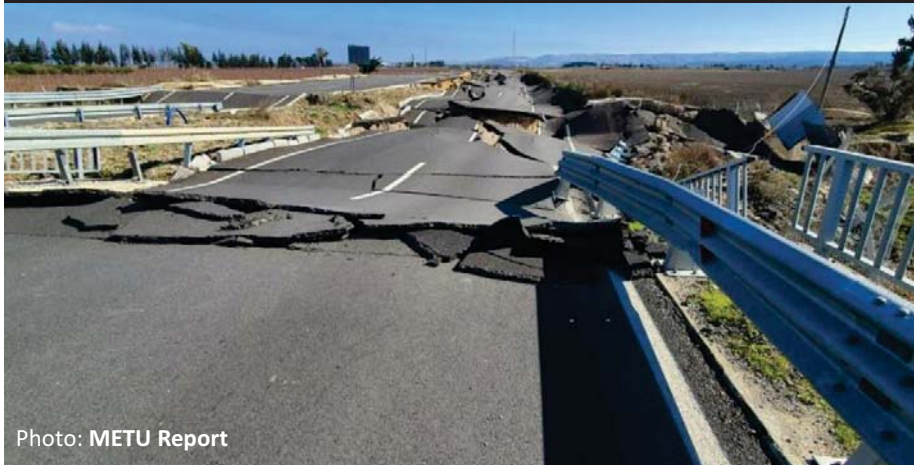
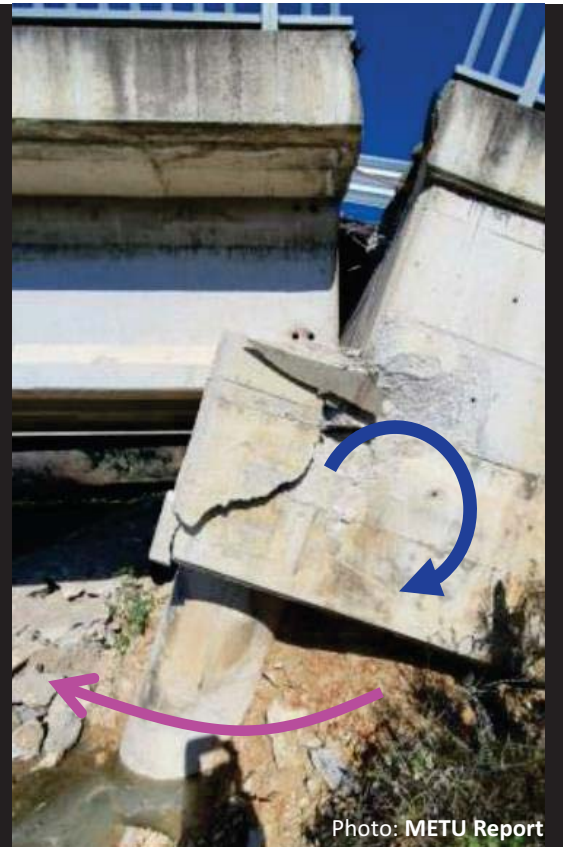
Bridge abutment rotation due to seismic induced foundation failure

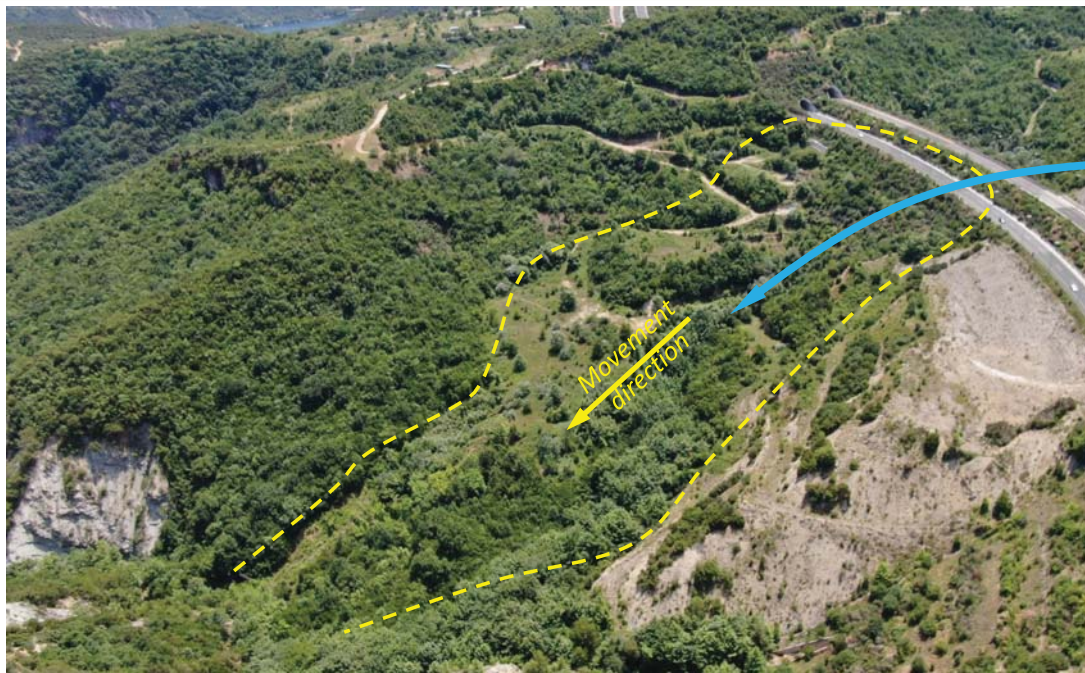
**600m long x 200m wide x 60m deep with an estimated volume of 5 million m<sup>3</sup> moving at a rate of 1-2cm/year**

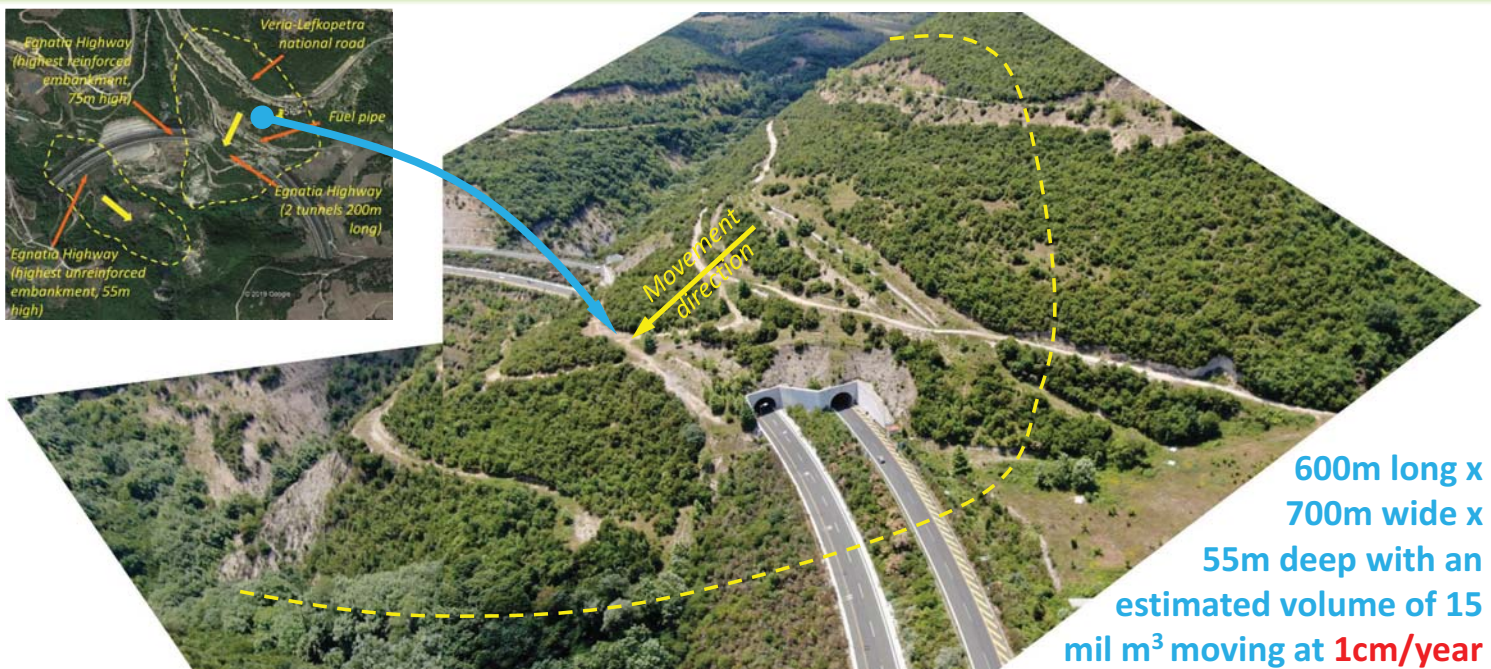
**600m long x 700m wide x 55m deep with an estimated volume of 15 mil m<sup>3</sup> moving at 1cm/year**
